Poultry Engineering, Economics & Management

Newsletter of the National Poultry Technology Center, Auburn University

Produced in cooperation with the U.S. Poultry & Egg and Alabama Poultry & Egg Associations
Issue No 68, October 2010

Poultry House Light Dimming Issues

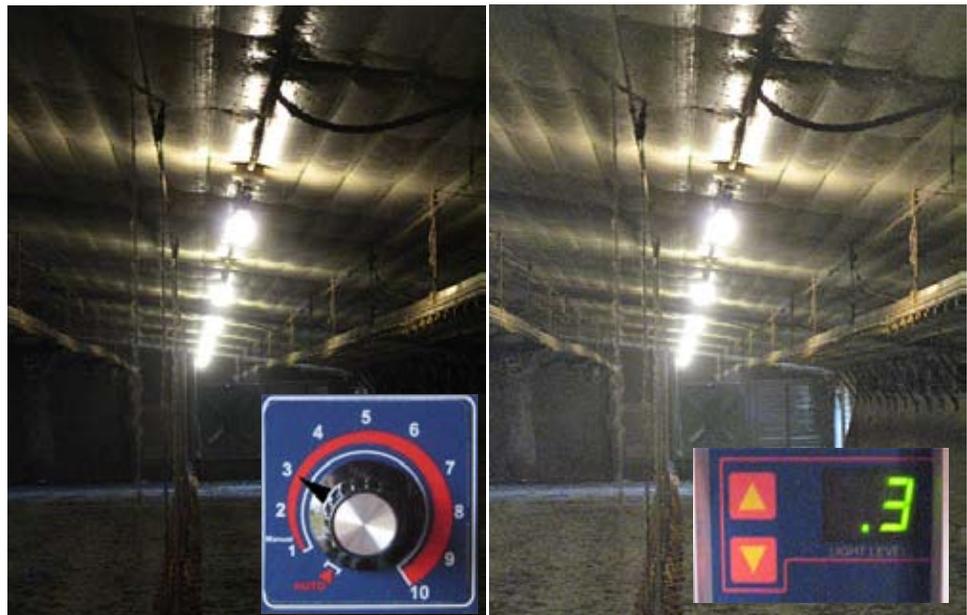
Photos of the same house but with lighting controlled by different dimmer models illustrates how the same dimmer percentage setting – here 30% or 0.3 – is likely to produce very different actual light intensity levels.

THERE IS NOTHING WRONG WITH THE DIMMERS.

They simply need to be set at whatever points on their dial or display that will produce the needed light level – as measured in foot-candles, not percentages.

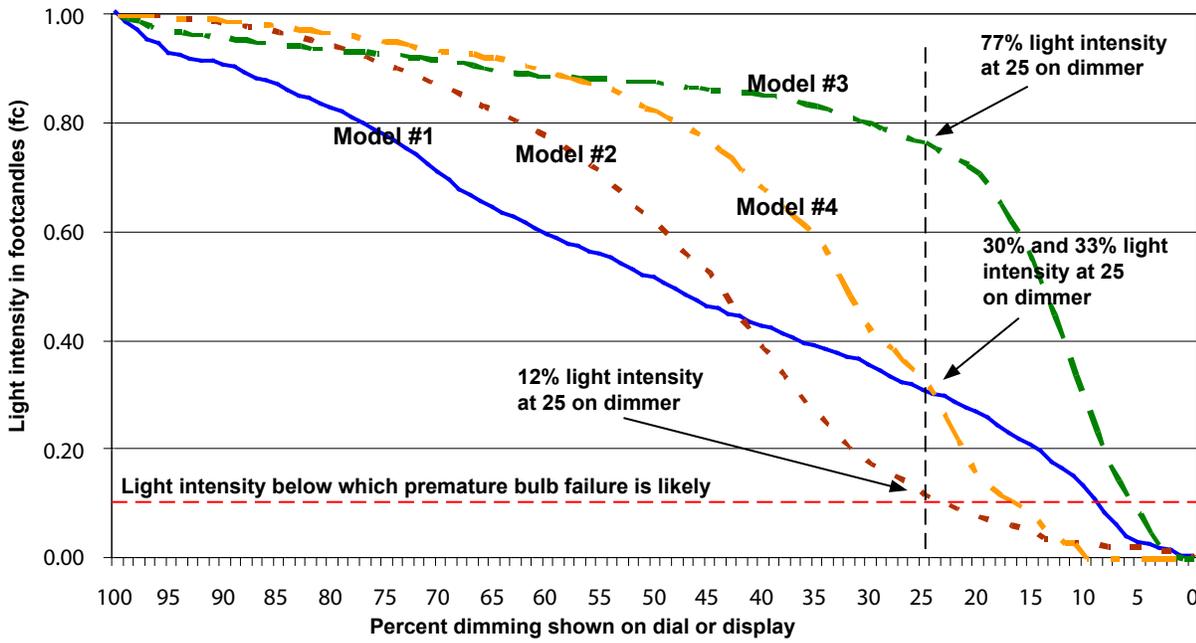
Light Intensity Produced by Four Example Dimmer Models

The chart on page 3 shows the different light intensity levels produced by four of the dimmer models tested by NPTC under identical conditions. The dimmer settings run along the bottom, and the light intensity produced by the four example dimmers at any given setting is shown by the curves, reading across to the light intensity in footcandles (fc) on the vertical axis. For example, at the 25% dim setting, Model #1 produces 0.30 fc, Model #2 produces 0.12 fc, Model #3 produces 0.77 fc, and Model #4 produces 0.33 fc.

Notice that Model 1 and Model 4 are very close at the 25% dial/dimmer setting, but far apart at other settings: Model 3 and Model 4 are close to the same at a 50% dimmer/dial setting, but far apart at other settings.

Thus, a setting of 25% on a dimmer dial/display is specific to a particular brand and model of dimmer. Again, there is nothing wrong with any of the four dimmers tested. And unless a particular dimmer is shown to actually be defective, a grower with light level problems should not be looking to purchase new dimmers. In almost all cases, the grower simply needs to “calibrate” his dimmers. That is, the grower needs to know for every stage of the growout what actual light intensity (in footcandles) is needed, then use a light meter (at bird level) to determine whatever dial or display reading on the grower’s dimmer produces that number of footcandles. Consequently, company dimming programs should specify the desired footcandle readings during growout, and not just % dim settings.

Chart above shows the different light intensity levels produced by four dimmer models, as tested by NPTC. The dimmer settings run along the bottom, and the light intensity produced by the four example dimmers at any given setting is shown by the curves, reading across to the light intensity in footcandles (fc) on the vertical axis. The curves show clearly marked differences in light output of the four dimmer models at the same dimmer dial/display settings. Notice for example that while Model 1 and Model 4 are very close at the 25% dial/dimmer setting, they are far apart at other settings.

Model-to-model differences do not mean there is anything wrong with any of these dimmers. A grower simply needs to know what light intensity in footcandles is needed, then test to find out what settings on his dimmers produce that light intensity.
