Problems With Blown-In Insulation In Dropped-Ceiling Houses

Blown-in cellulose insulation is an excellent, low-cost insulating material that is very commonly used in poultry houses. However, it has a tendency to shift over time away from the centerline peak of the ceiling, allowing significant heat losses in winter or during brooding, and heat gains in hot weather. See inside for steps you can take to spot this problem and to prevent it from cutting into your bottom line.

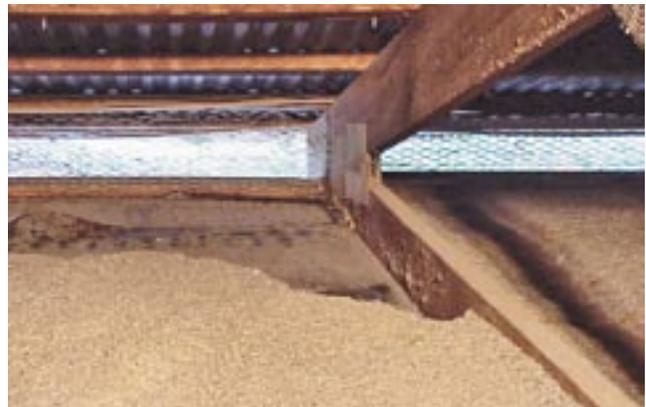
Photo shows how wind can push blown-in insulation away from the eave, leaving the ceiling along the sidewall without insulation. In cold weather, this is likely to show as beads of condensation on the tri-ply. Blocking should be installed along the sidewall to prevent this from happening, and also to prevent insulation from sliding into the eave venting area.
