The Poultry Engineering, Economics & Management
NEWSLETTER

Produced in cooperation with the U.S. Poultry & Egg and Alabama Poultry & Egg Associations
Issue No 58, March 2009

Sealing Concrete Foundation Air Leaks

By Jess Campbell, Jim Donald and Gene Simpson, Auburn University

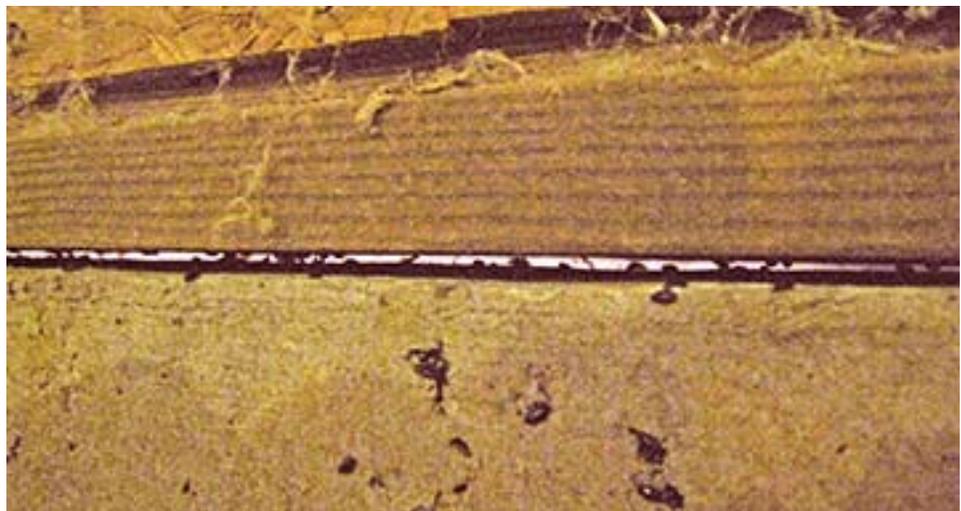
Voids like this at the top of a concrete stemwall are fairly common in poultry houses built with foam sill sealers that have been destroyed by darkling beetles. Running around the entire perimeter of the house, the air-leak can easily be equivalent to leaving a man door wide open. Just walking around in the house, you can't see a crack like this. A closer inspection might show you where all those dollars have been going.

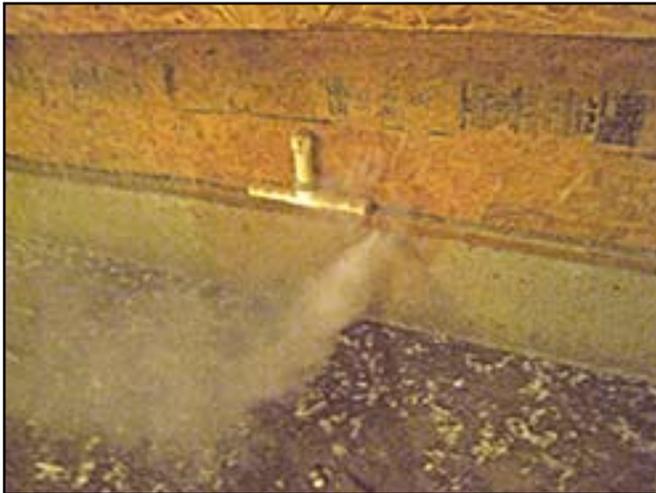
The two pictures at the top of Page 3 show a poultry house side wall at the foundation. The picture on the left was taken during a smoke test. The smoke shows outside air leaking into the house. The picture on the right shows exterior light shining between the surfaces of the concrete wall foundation and the bottom lumber plate of the side wall. The cause of the leak was damage to the foam sill sealer, originally installed between these two surfaces during construction, by darkling beetles over just a short period of time. The problem is that this air leak is likely to be 800 to 1,200 feet long. Leaks like this worsen the condensation problem on the concrete foundation in cold weather, cause litter moisture problems along the sidewall, allow cold-air drafts on the birds and increase heating system run times during winter. Leaks like this also allow outside air to bypass the attic inlets, sidewall or ceiling inlets, and tunnel inlets. It is a serious uncontrolled air leak which allows unconditioned and uncontrolled air to enter the house, and it needs to be repaired.

Solid wall house smoke test shows air leak between top of concrete foundation and lumber plate, probably caused by darkling beetle damage.

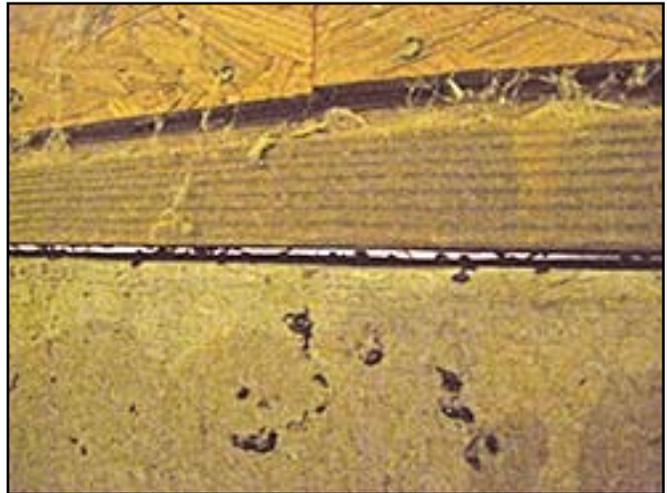
See-through void above foundation of solid wall house may extend around the entire house, an air leak easily equivalent to a wide-open man door.

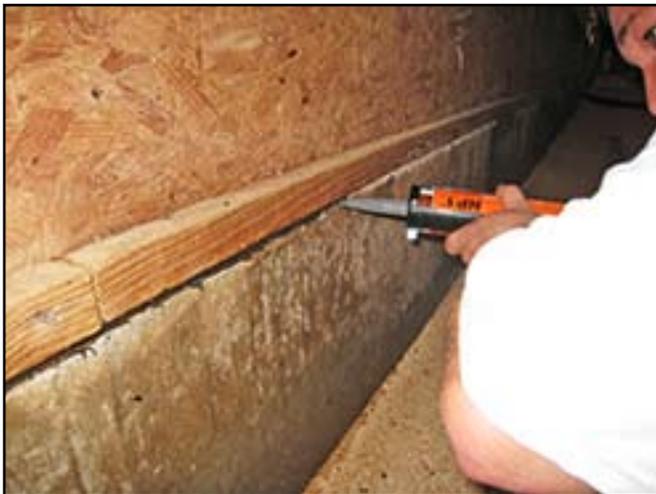
The picture in the middle left of page 3 shows a grower injecting expansion joint sealant into the void between the concrete stemwall foundation and the bottom plate of the lumber wall. The picture on the middle right shows the void in the wall completely filled with the expansion joint sealer, thus achieving an air-tight seal between the two materials.

Grower injects foundation sealant using an ordinary caulking gun. Voids must be thoroughly cleaned before applying sealant.

Before installing the sealer the void must be free of moisture, shavings, and darkling beetles to ensure that a consistent sealing and adhesion to the concrete and lumber are made possible. We recommend using a kitchen broom and a high velocity blower (leaf blower) to clean the void and prepare it for sealing. It is not recommended that any sealer be applied to the void if moisture is present on the concrete foundation or lumber seal plate. It is not recommended that excessive static pressures be placed on the house immediately after installing the sealer or before the sealer is allowed to cure.

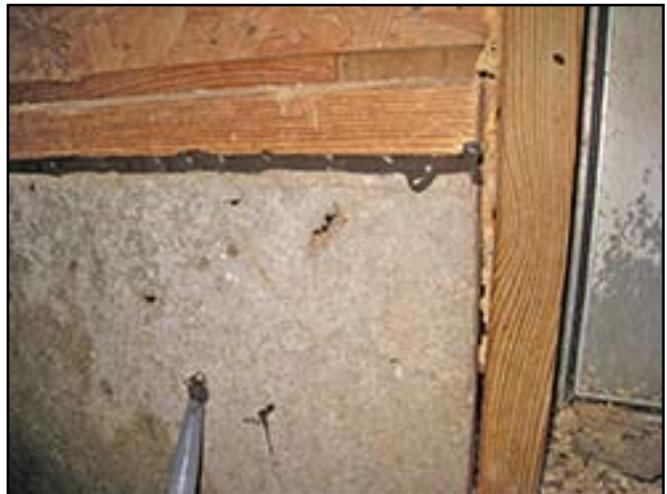
Freshly sealed void should be allowed adequate time to seal per label directions before applying static pressure.
