Operation & Maintenance Problems of Center Pivot Irrigation

New May 2021, ANR-2772

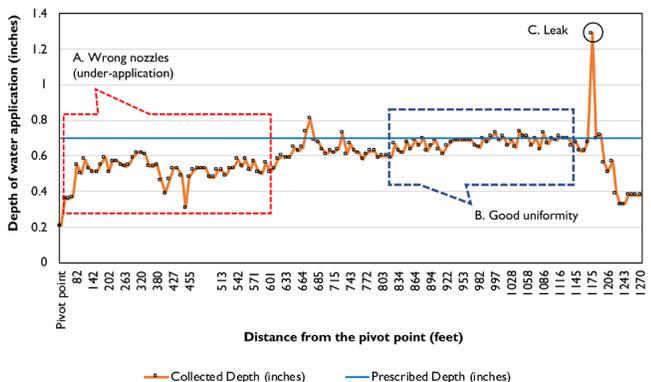
Figure 1. Common problems with uniformity of water application identified using a catch-can test.

The common causes of poor uniformity in water application of pivot irrigation systems are related to inadequate pump operating pressure and/or flow rate, incorrect nozzle size and placement (figure 1[A]), worn or clogged nozzles, missing sprinkler heads, and leaking boots (flexible unions between span pipes) (figure 1[C]), and incorrect control panel settings. These issues not only reduce the efficiency of water application but also increase the risk for yield losses and increase water pumping time, thus increasing energy use, leading to higher irrigation costs. Before starting a new irrigation season, have a field evaluation of the irrigation system or use a catch-can test to assess the uniformity of water application and to identify problems (figure 2).

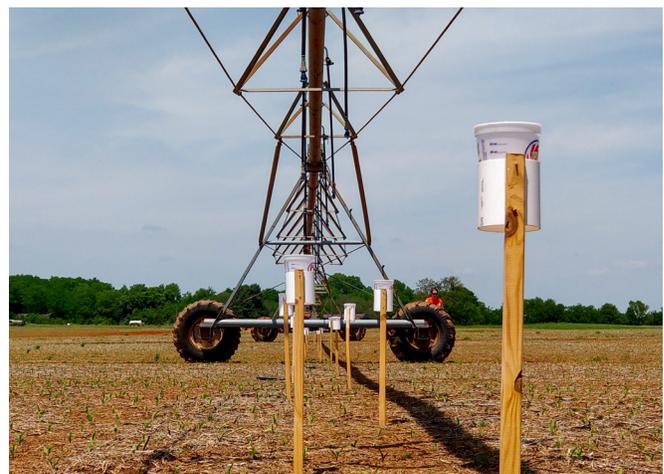
Figure 2. Uniformity of water application on a center pivot irrigation system assessed using a catch-can test.

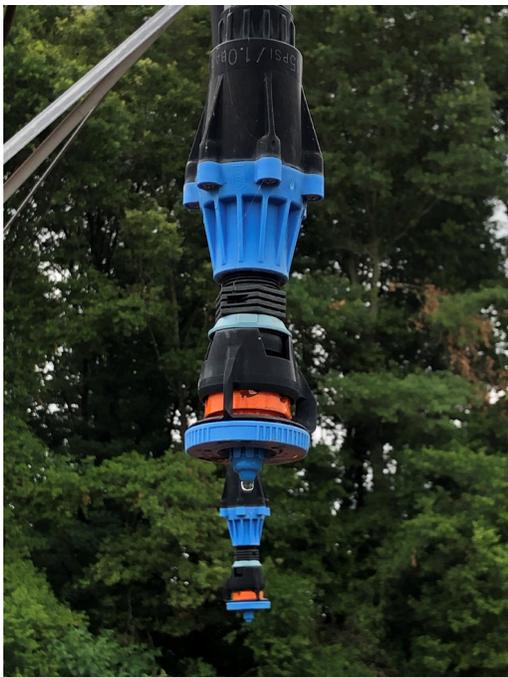
Figure 3. Sprinklers with rotator nozzles and pressure regulators.

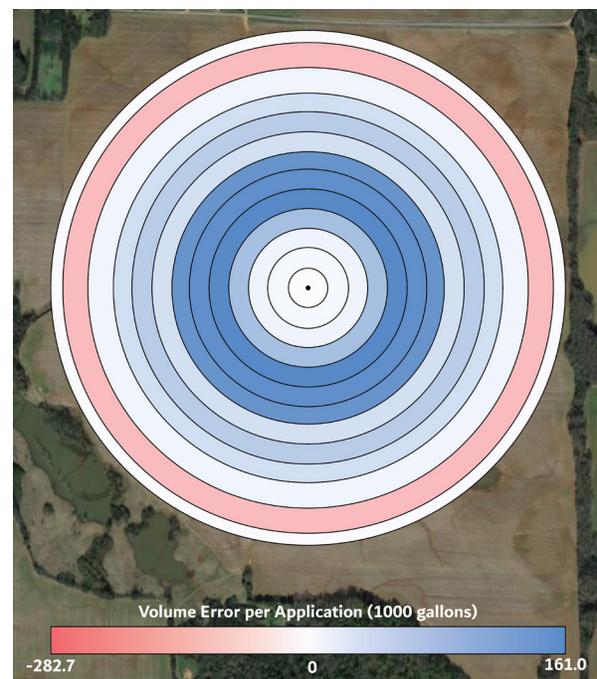
Figure 4. Overapplication of water, especially on spans 4 to 7 out of 12 due to reduced pump pressure.

The impact of operating a 2,036-foot center pivot irrigation system below the designed pressure was studied in 2020. In the study, surface water was pumped from a creek into an irrigation pond and from the pond to the pivot. The pivot had 12 spans plus the overhang and 219 sprinklers equipped with low-pressure spray heads, rotating deflection pads, and 15-pound per-square-inch (psi) pressure regulators (figure 3). According to the sprinkler chart, the system was originally designed to pump water at a pressure of 80 psi and a flow rate of 1,500 gallons per minute (GPM). However, the farmer was only able to pump water at 50 psi; therefore, an analysis was conducted to determine how reduced psi affected water application. Reducing the operating pressure from 80 to 50 psi caused overapplication of water, 18 percent on average, throughout the entire system but especially on spans 4 to 7 (53 percent average overapplication). The dark blue rings in figure 4 show where the overapplication occurred. Since the sprinkler chart showed the system was originally designed for a pumping pressure of 80 psi, it was determined that the nozzle sizes were too large when the pump was operated at 50 psi. For example, the original sprinkler chart for an 80-psi pump recommended a 30-32 nozzle size for sprinklers 42 to 50 (span 5). However, if the pivot is operated at 50 psi, 25-26 nozzle size should be used for the same sprinklers. To prevent this specific problem, irrigation operators should frequently check the pump pressure (manually or automatically) and monitor water source levels (well or pond) to identify potential impacts to pumping pressure.

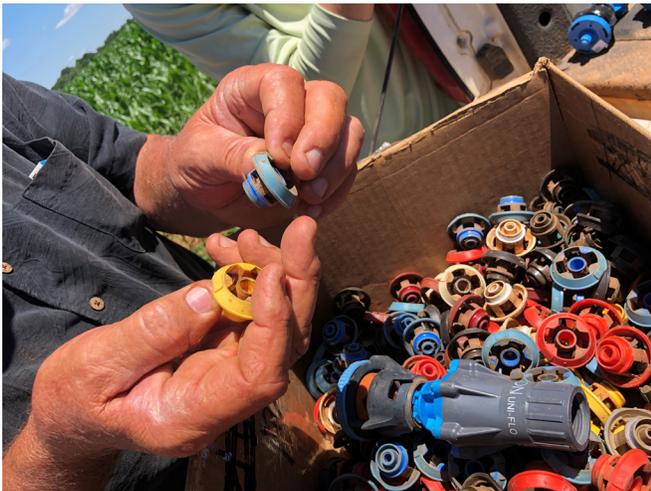
Figure 5. Most sprinkler companies use different colors to differentiate the nozzle sizes.

The color of the nozzles corresponds to different nozzle sizes, and the shape and color of the spray plate indicate a specific width of throw (figure 5). Nozzle size and plate shape are designed for specific pressures; therefore, when replacing a missing or worn sprinkler, it is important to check the sprinkler chart to select the right nozzle size and type according to the specific sprinkler number on the pivot. A uniformity of water

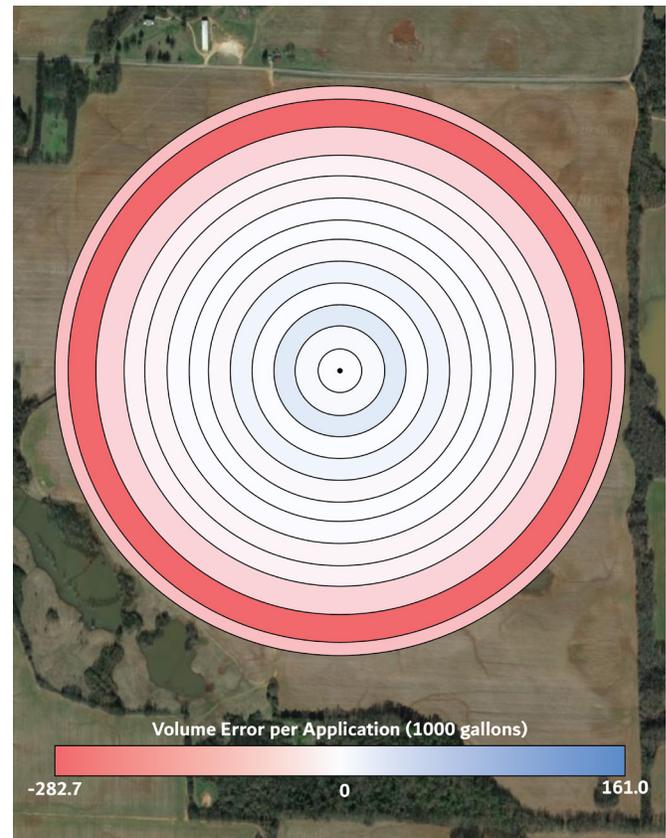
Figure 6. Wrong-size nozzles can cause over- or under-application of irrigation water.

The uniformity of the water application test indicated significant under-application of water on the outer spans of the pivot (figure 6). The pivot was set to apply a uniform rate of 0.6 acre-inches, and the test results showed under-application of 6 percent, 20 percent, and 14 percent on spans 11, 12, and the overhang, respectively (figure 6).

The cause of under-application on spans 11 and 12 and the overhang was associated with smaller nozzles than indicated by the sprinkler chart. The reason for the under-application is simple: smaller nozzle openings, also called orifices, restrict the flow of water, leading to decreased water application. It is important to remember that the outer spans travel much farther per revolution of the pivot and therefore cover substantially more area than the inner spans, so application errors (either under- or overapplication) in outer spans may have disproportionately large negative impacts on yield compared to inner spans. In the case of the pivot in this example, spans 11, 12, and the overhang covered 127 acres corresponding to 38 percent of the total irrigated area (329 acres) by this pivot.

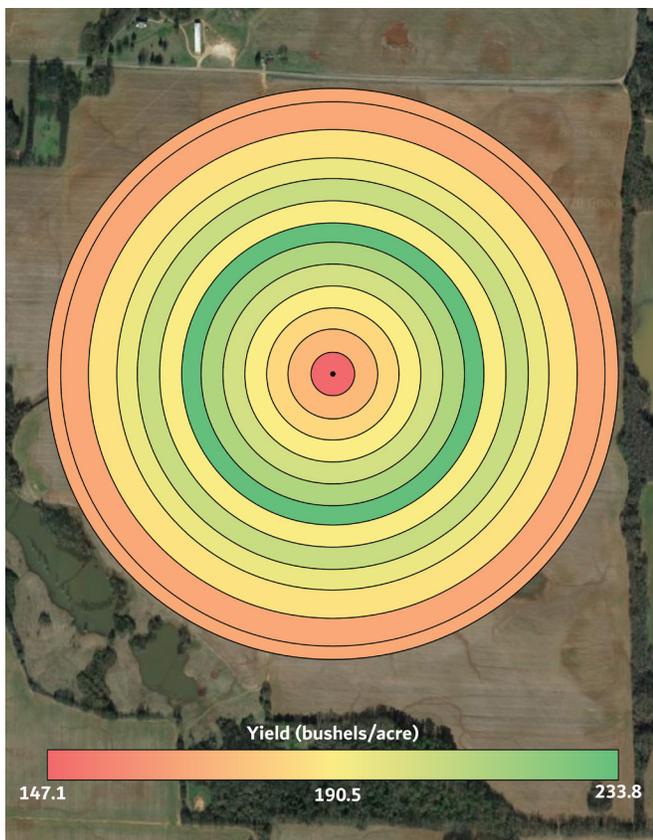
Figure 7. Yield differences by span mostly associated with pivot maintenance problems.

As shown in figures 7 and 8, the lowest yield and net returns were estimated for the whole field but specifically for span 12 and the overhang. Net returns for span 12 and the overhang were approximately 47 percent lower compared to the average net returns of the irrigated area.

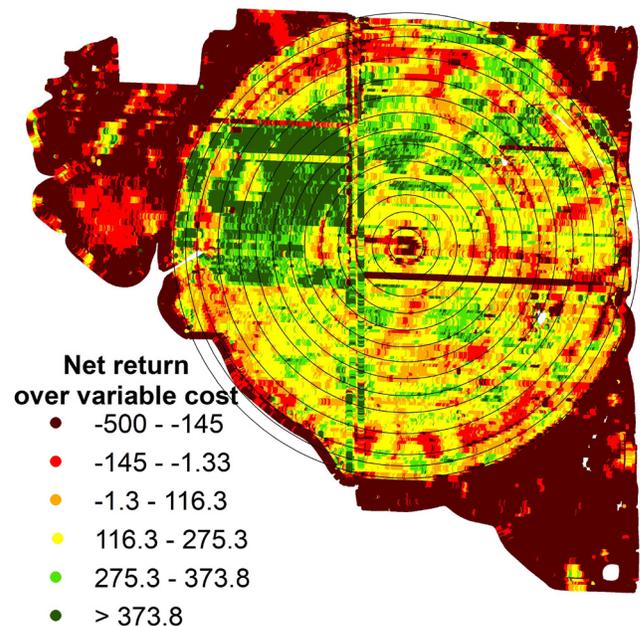
Figure 8. Spatial analysis of net returns across irrigated and dryland areas shows the economic impact of irrigation and pivot maintenance.

Dryland areas surrounding an irrigated field are also a clear indicator of the benefit of irrigation—where irrigated yields are similar to dryland yields, there is potentially a problem with the irrigation system. As shown in figure 8, assuming the dryland corners were managed with the same production practices as the irrigated area, the farmer incurred negative net returns on average. There were small areas of positive net returns above variable costs in the dryland corners; however, these areas were a minor portion of the dryland area. The net returns depend on the corn price and production costs, which do differ by producer. Growers should keep records of production costs associated with the dryland areas of irrigated fields as it may be financially beneficial to leave those areas fallow or enroll them in a conservation program.

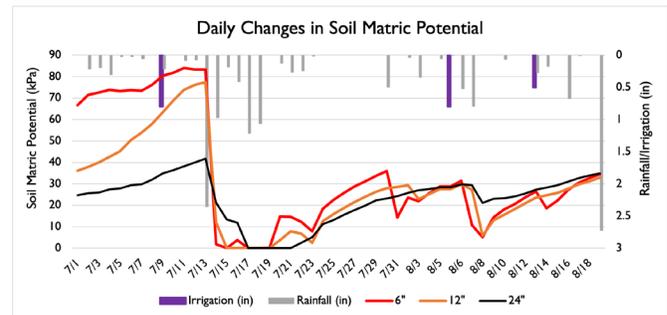
Figure 10. Daily changes in soil matrix potential as a result of rainfall or irrigation.

hours to cover the field. Instead, the pivot took 14 hours to complete the cycle. These discrepancies were the result of a machine error not detected by the farmer. An irrigation event of 0.8 acre-inches should decrease soil water tension (SWT) and increase soil moisture at least in the top 6 inches of soil; however, no changes in SWT were registered that day (figure 10). On July 30, a rainfall event of 0.5 inches resulted in a decrease in SWT in the top 6 inches of soil (figure 10). Even though the changes in soil water at various depths resulting from rain or irrigation were not the same, irrigation of 0.8 acre-inches should change soil water to a degree similar to a rainfall event of 0.5 inches. On August 5, the farmer set the pivot to apply 0.8 acre-inches, and as on the earlier date, the pivot completed the cycle in 14 hours instead of the predicted 56 hours. As a result, approximately 0.2 acre-inches of irrigation water were applied. The soil sensor recorded no significant changes in SWT on August 5 or 6 because of this irrigation event (figure 10). This example shows how data from soil moisture sensors can also help farmers assess problems with irrigation water application.
