TIMELY INFORMATION

Agriculture & Natural Resources

Rainwater Harvesting from Rooftops for Non-potable Uses in Alabama Part II - Field Application of RCR system

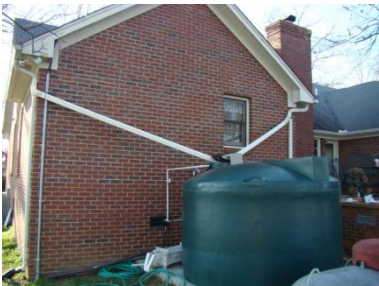
Site 1

Storage tank and roof lines

Field photos of the five study sites are shown in Figure 1. The water meters shown were used to monitor water use at the sites. For simple RCR systems no water meters will be needed.

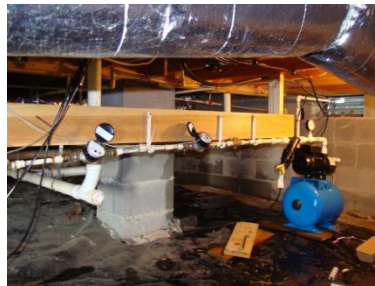
Pump, pipes, and water flow control in the crawl space

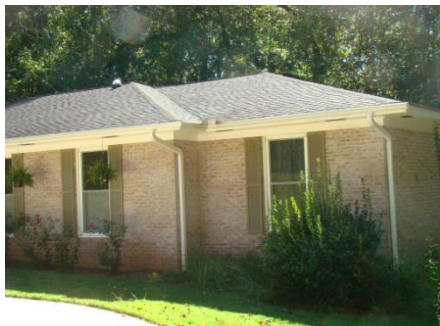
Site 2

Roof lines

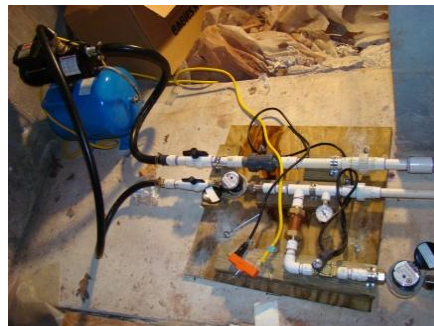
Water flow control, pump and pressure tank located in the basement

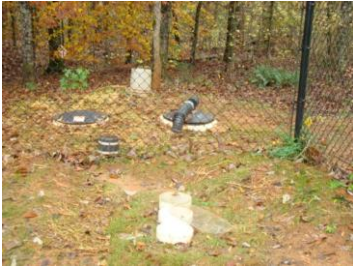
Site 3

Underground storage tank with buried pipes

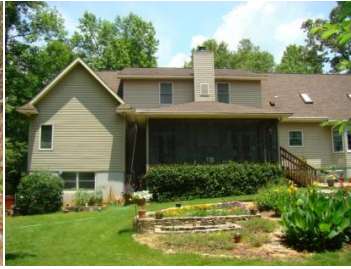
Roof lines

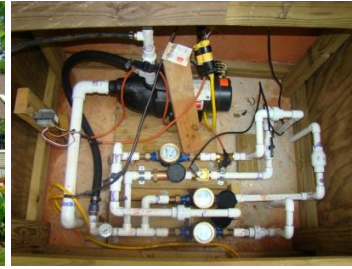
Pump and water flow control in an insulated wooden box

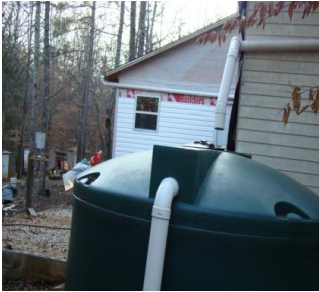
Site 4

Storage tank and roof lines

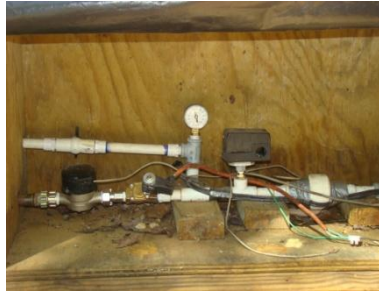
Flow control in the crawl space

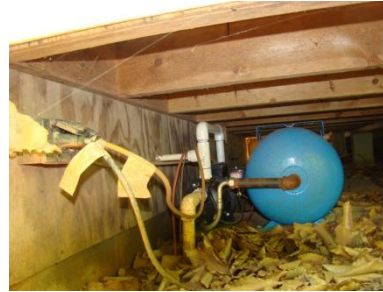
Pump and pressure tank located in the crawl space

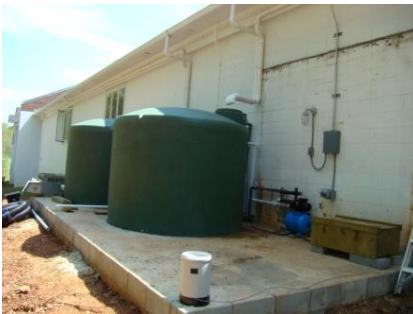
Site 5

Storage tanks and roof lines before an insulated shed was built to house the RCR

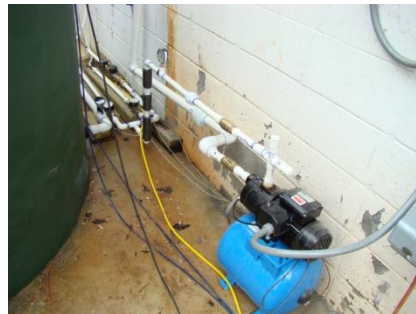
Pump and pressure tank

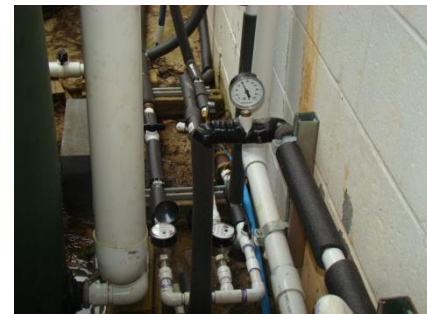
Water flow control
